**Building Performance Inspection  
Including Moisture and Mold Assessment  
Harold Kelly Murphy Residence, Montgomery, AL**

**Report completed by: Francis Conlin, PE, CMR  
Site investigations: October 24, 2007 and December 4, 2007  
Report Date: December 28, 2007**

**In Reference to  
Harold Kelly Murphy v. Southern Homes**

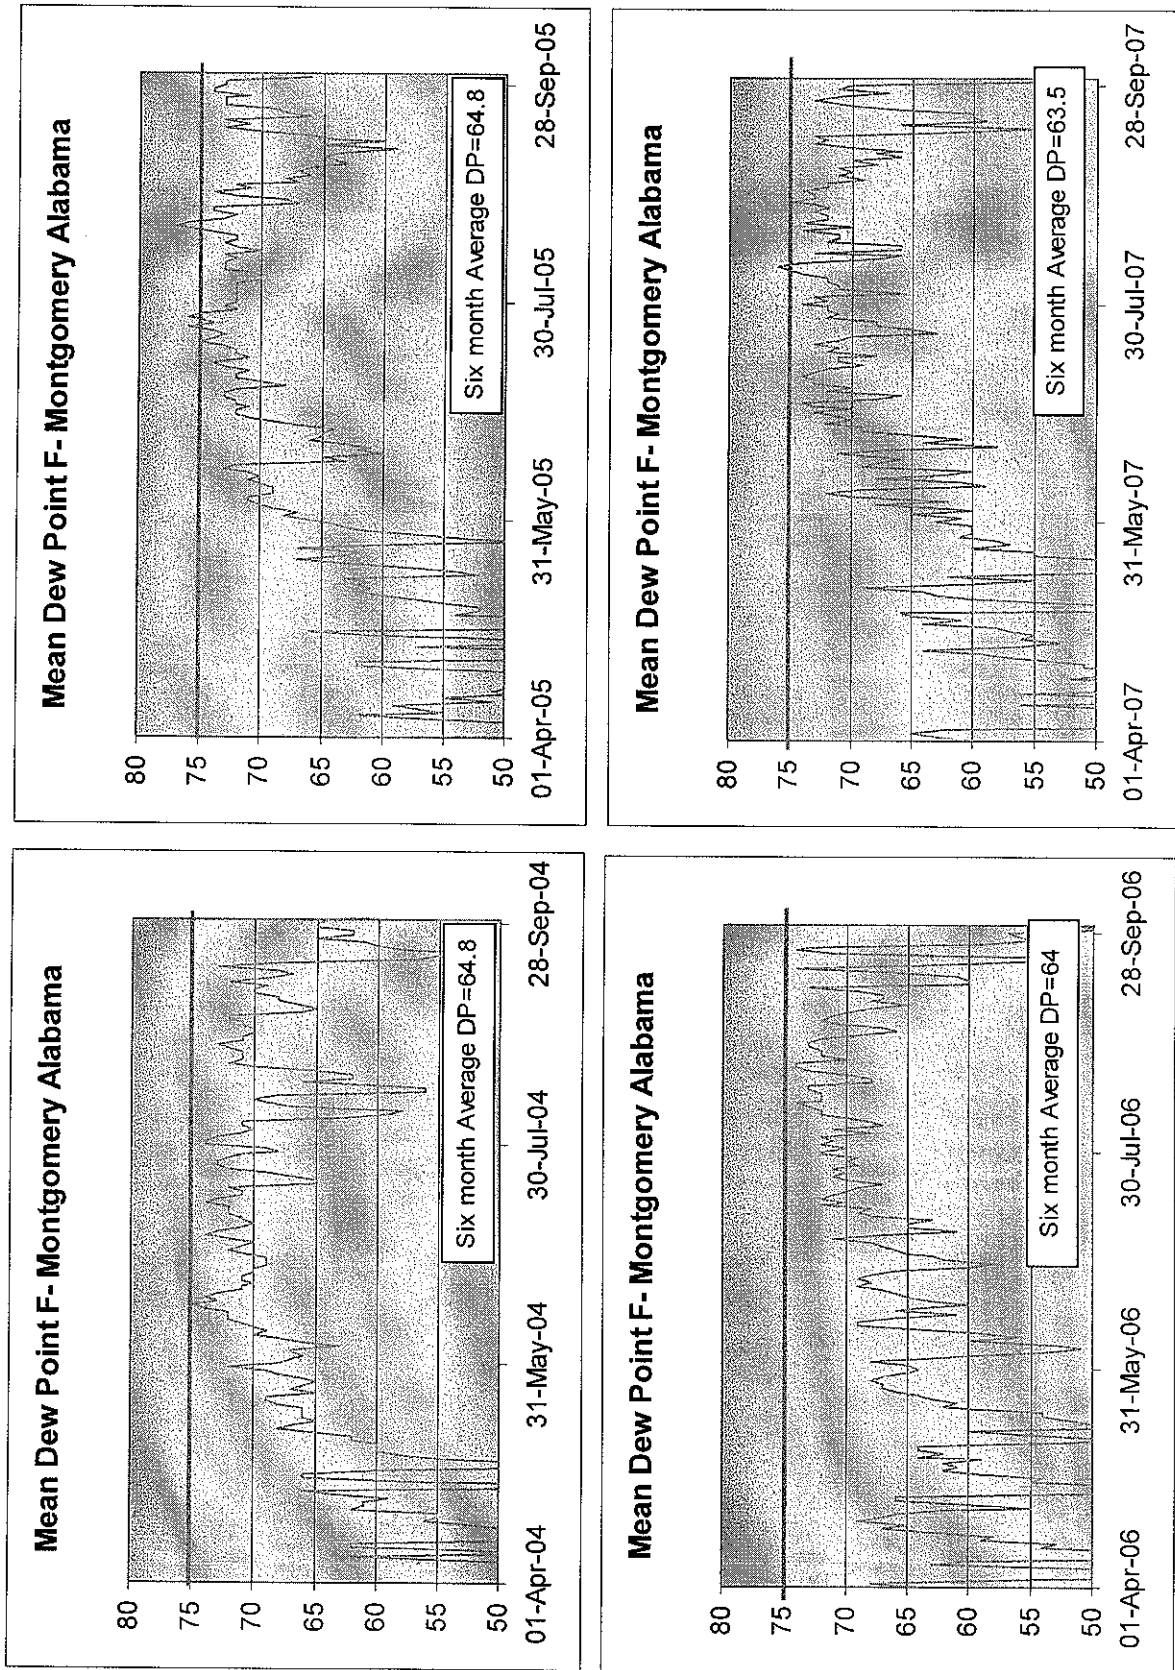
Figure 1. Mean Dew Point Montgomery, Alabama Summer 2004 -2007

The mean dew point temperature (not maximum dew point temperature) is the appropriate term to describe climate effects on wall cavities, regardless – even maximum dew point does not exceed 75°F to the degree claimed.

Mean dew point is the appropriate weather condition to evaluate the effect of climate inside a wall cavity and is used in guidebooks for that purpose.<sup>7</sup> Whereas instantaneous dew point will show effects on a glass of ice tea that, A) has no capacity for moisture storage, and B) is completely open to the outside air – this in no way reflects the conditions inside a wall cavity which are separated

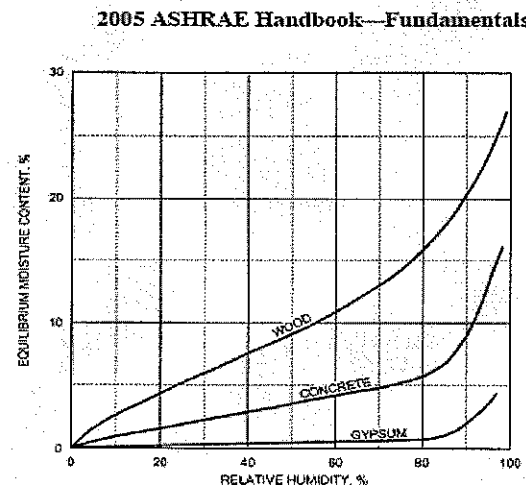
Figure 2. Adsorption isotherms for Wood, Concrete and Gypsum

Gypsum above 10% moisture content is a slurry. The adjoining Figure 2 shows the commonly accepted moisture content adsorption isotherm for a variety of construction materials including gypsum. The ASHRAE adsorption isotherm for gypsum is seen to have relatively stable moisture content of a few percent throughout a large range of equilibrium relative humidity.<sup>14</sup> A key HH claim is reported elevated moisture content readings: "Consistent readings within the Murphy's perimeter gypsum walls were in the 25%-40% range. (HHR 5-22-06) Page 3, Paragraph 3. Gypsum wallboard cannot have a 25-40% moisture content. The HH expert misrepresents moisture content measurements of the gypsum wallboard.

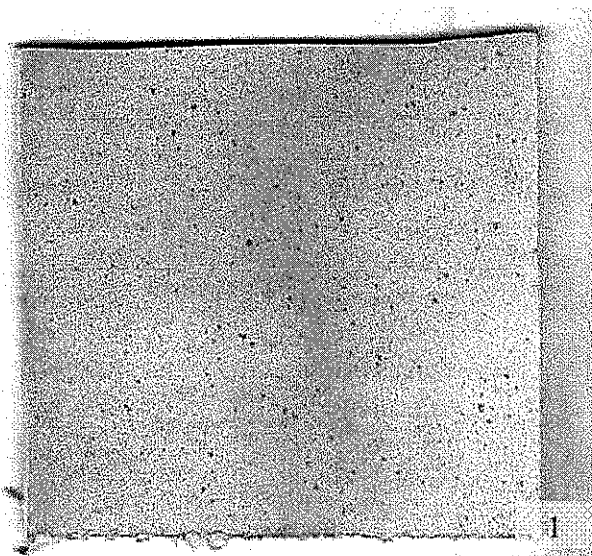
Photo 1: Interior view of new gypsum wallboard as delivered to factory. Spots (freckles) are a normal feature of the boards and should not be confused with mold.

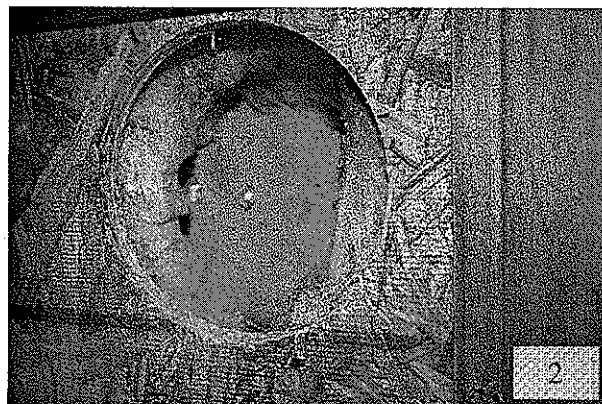
Photo 2: Living room wall cavity -MS (10-24-07) ■8- sample location at exterior wall near the porch light penetration. The exposed wallboard, wood framing and batt insulation are in like-new, pristine condition. Wall cavity observation was Condition 1 or "normal fungal ecology" and no adverse fungal evidence was present that suggests that the walls need or will need replacement. Evidence of the Healthy Homes wall check test is seen as the holes penetrating the interior wallboard. (HHR 5-22-06) ✕3.

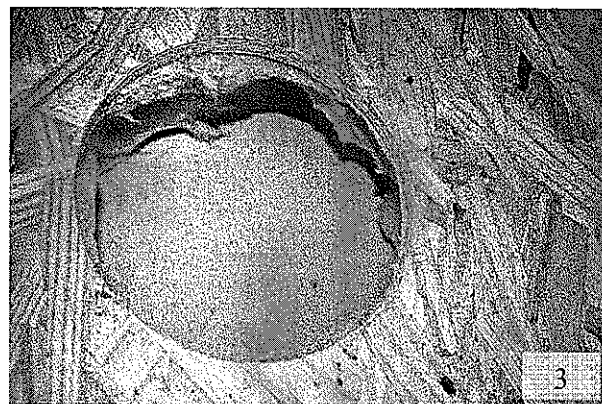
Photo 3: Kitchen end wall -MS (10-24-07) ■7- sample location; wall cavity observation is Condition 1. The exposed wallboard, wood framing and batt insulation are in like-new, pristine condition. (Healthy Homes did not sample this wall.)

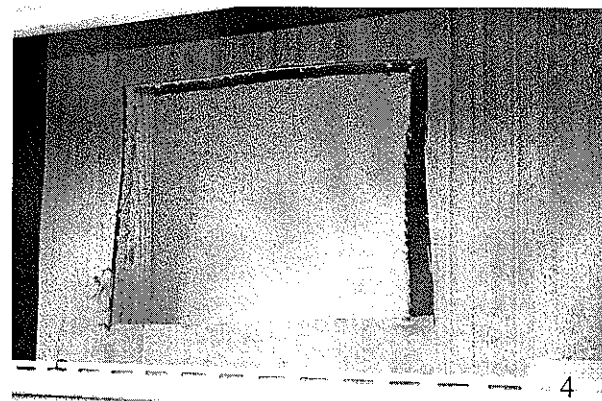
Bedroom #2 end wall -MS (10-24-07) ■9- sample location at exterior wall. The exposed wallboard, wood framing and batt insulation are in like-new, pristine condition. Sampling site by HH could not be located in this wall.
